INVESTIGATION OF THE GENERATOR ROTOR BURST AT THE PITTSBURG STATION OF THE PACIFIC GAS AND ELECTRIC COMPANY

Large Steam Turbine-Generator Department

General Electric Company, Schenectady, New York

The recent fracture of a large generator rotor (125,000 kw - 3600 rpm) led to an extensive investigation aimed at determining the cause. This paper describes the various facets of this investigation, the results obtained, and the probable cause of the burst.

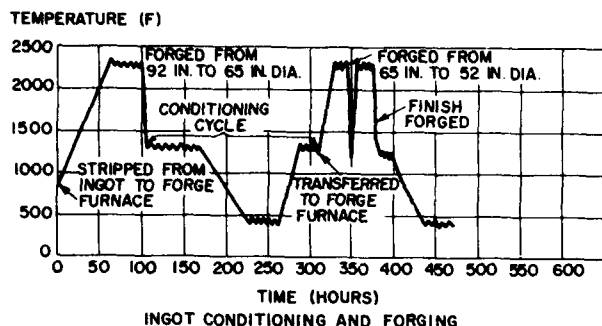
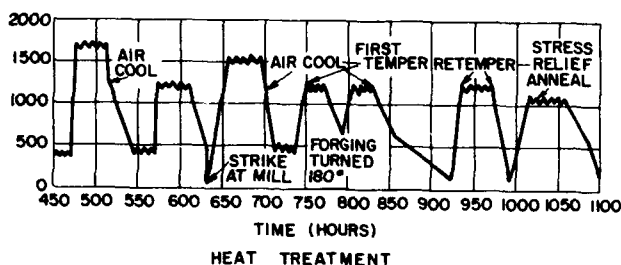
Due to a pending strike at the steel mill, the usual practice of double normalizing following by tempering was modified to permit storing the forging. The heat treating sequence consisted of a normalize from 1640 F, and a temper at 1200 F prior to the strike. When work was resumed, the forging was given a final normalize at 1550 F and a double temper at 1200 and 1220 F respectively. It was stress-relieved at 1100 F after rough machining. The complete thermal cycle is presented in Fig. 3.

Fig. 3. Complete thermal cycle

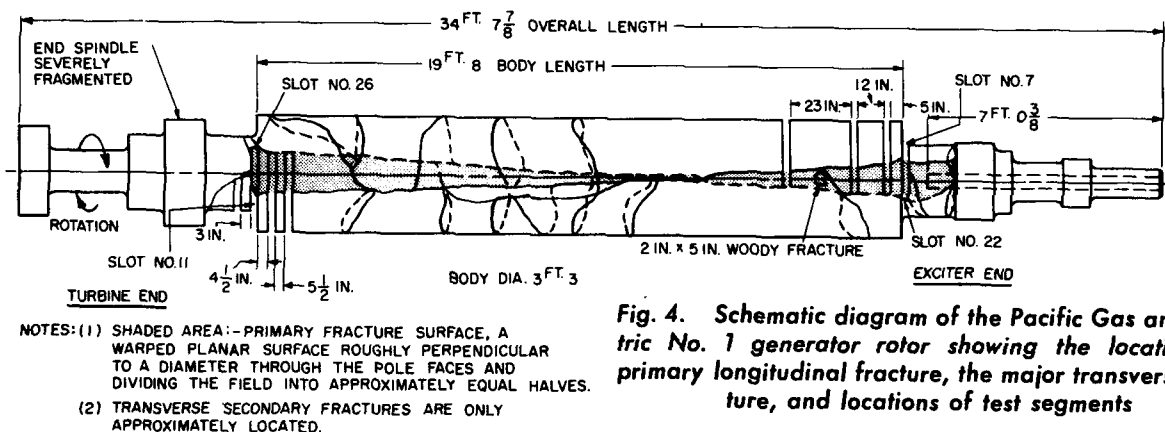
To ascertain if there were any abnormalities in the rotor (obviously not apparent in the acceptance tests results) which might explain the low average-stress-level burst, numerous tests, such as mechanical, notched bend, fatigue and others, were obtained on specimens from the rotor fragments. The locations of the fragments discussed in this paper are shown in Fig. 4. A brief summary of these test results follow.

Fig. 4. Schematic diagram of the Pacific Gas and Electric No. 1 generator rotor showing the locations of primary longitudinal fracture, the major transverse fracture, and locations of test segments

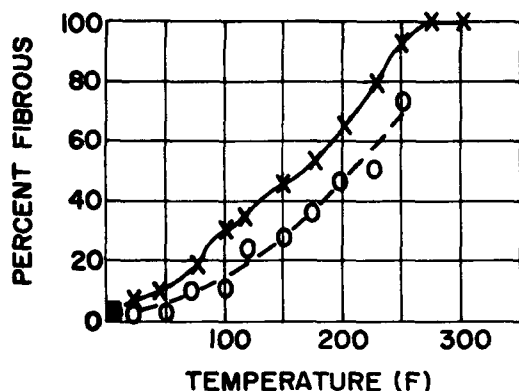
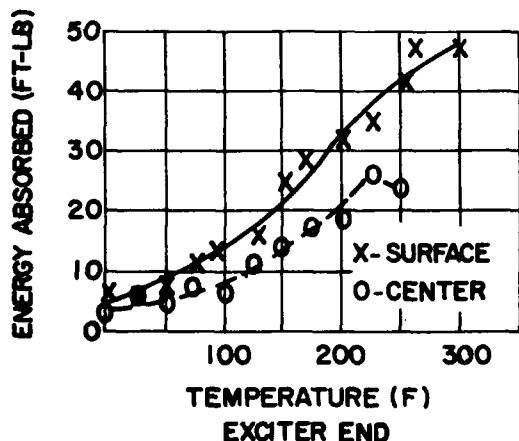
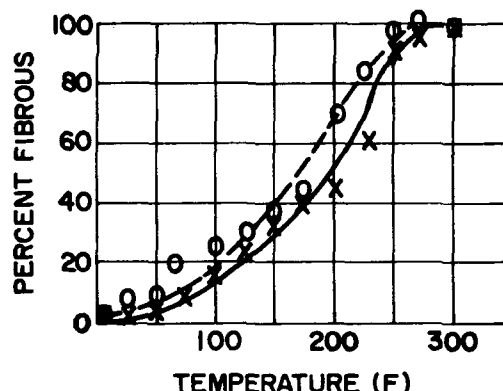
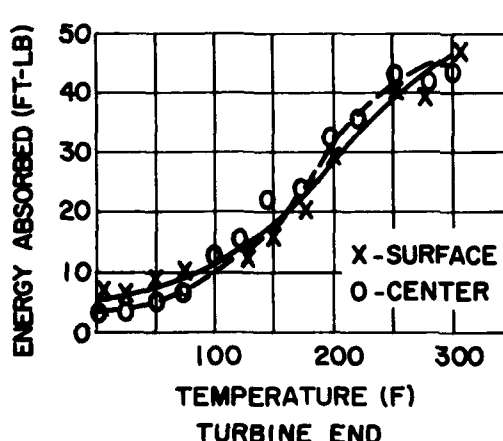
The energy absorbed and fracture appearance of the Charpy specimens over a range of temperature is presented in Fig. 5. These results show a variation in fracture-appearance transition temperature with location in the forging which is summarized in Table 4.

The main-body temperature was estimated as about 85 F when the forging burst, and at this temperature the center material at the exciter end has a V-notch Charpy impact value of 7 ft-lb, indicating relatively low resistance to crack propagation.

Fig. 5. Charpy V-notch impact-energy and fibrous-appearance curves

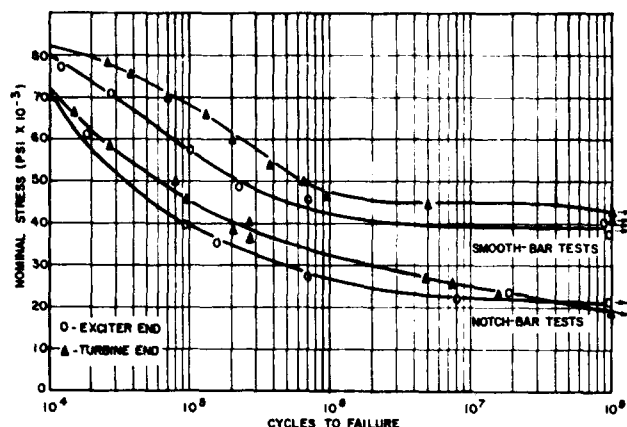
Fig. 6. Smooth and notched-bar fatigue strength

Fatigue test results from smooth- and notched-bar cantilever specimens, in the radial direction of material from the exciter and turbine ends of the forging body are shown in Fig. 6. The cross-section of the smooth bar was 0.343 inch x 0.625 inch. The notched bars were 0.493 inch x 0.625 inch, with two notches 75 mils deep giving a net section the same as the smooth bar. The radius at the bottom of each notch was 20 mils. This gave a theoretical stress concentration factor of approximately 2.6. The 10^8 -cycle smooth-bar fatigue strength is 37 percent of the tensile strength at the exciter end and 40.7 percent at the turbine end, while the notched fatigue strength is 20.7 and 18.7 respectively. These results are similar to those obtained on several other large turbine and generator rotors so far examined.

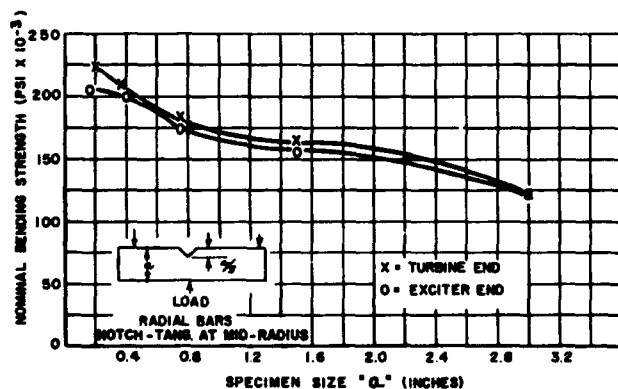
Fig. 7. Notched-bend strength, Pacific Gas and Electric rotor No. 1

3/16-in. to 3-in. square. Test results from mid-radius locations at the exciter and turbine ends of the main body are shown in Fig. 7.

Here nominal bending strength is merely the product of bending moment at fracture times the inverse-section modulus of the net section at the root of the notch. It will be noted that bending strengths of the notched bars decrease with increasing size of bar. Although the data presented were obtained at ambient temperatures, it has been found that the nominal bending strength of larger notch-bend specimens from similar material increased quite rapidly with moderate increases in temperature. Typical results are shown in Fig. 8. The material at the exciter end of the main body shows lower nominal bending strength than at the turbine end.

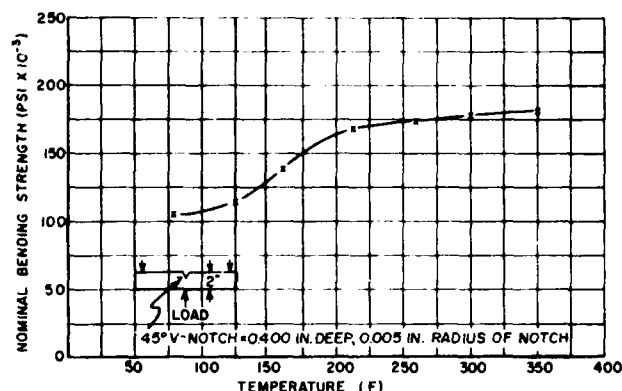
Fig. 8. Temperature dependence of notched-bend strength

While the stress levels required to produce fracture in the various notched-bend specimens are considerably higher than the stress of 24,000 psi which existed at the solid center of the Pittsburg rotor at 3920 rpm, these notch-bend tests do show decreased load-carrying ability with increase in specimen size; and further, that the material fractures rather than deforms in relieving severe localized stresses.

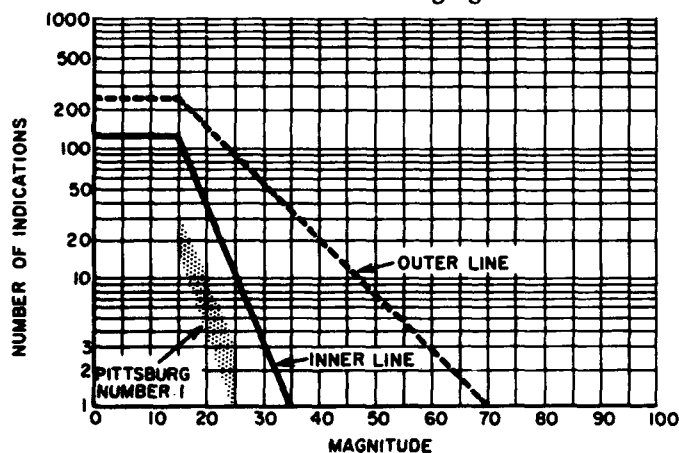
Original sonic examination had indicated there were only two minor indications up to 25 percent in magnitude in the vicinity of the fracture origin. From calibration of our sonic-test equipment, a 25-percent indication shows the presence of something no larger than a dime. It was concluded that the sonic indications were the result of small slag inclusions and the forging was accepted. This conclusion was consistent with the sonic-test acceptance standards as presented by Messrs. Rankin and Moriarty to the ASME in December 1955, in the paper "Acceptance Guide for the Ultrasonic Inspection of the Large Rotor Forgings." Figure 9 shows the approximate location of the number-magnitude line of the Pittsburgh No. 1 forging plotted with our so-called "inner and outer lines" from Fig. 12 of that paper. In cutting up nine rotors, and in the examination of 87 trepans from 30 other rotors, we had never found cracks nor other harmful defects in a forging whose number-magnitude line lay within the outer line and on which there were no traveling indications. The inner line was drawn parallel to the outer line at half the number and magnitude level of the outer line to define a region within which there appeared to be a high degree of certainty that no cracks or other harmful defects existed, based on all of our experience. As shown on this chart, the Pittsburgh No. 1 rotor lies well within the inner line. In addition, there were no traveling indications. By sonic test, and by all the standards and experience available, this was judged to be a sound and serviceable forging.

Fig. 9. Sonic-acceptance guide lines

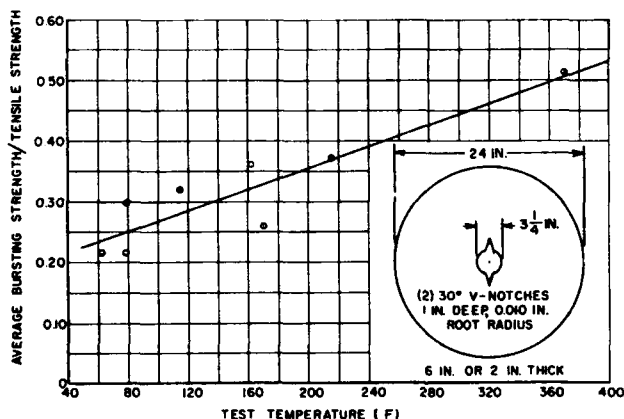
In addition to showing the increase in toughness with lower transition temperatures, the disk-bursting tests also show an increase in toughness with increasing test temperature. This is illustrated in Fig. 18, which is a plot of disk temperature and the

Fig. 18. Bursting strengths of notched disks as a function of temperature

ratio of average bursting stress to tensile strength of internally notched disks like those described, and having a transition temperature of 225 F. The curve shows a progressive increase in bursting strength from the lower to the higher temperatures. This increase is 20 to 30 percent over the temperature range of 70 F to 150 F. Because of this gain in strength and toughness with temperature, prewarming before startup of the larger and more highly stressed rotors has been recommended. The prewarming is carried out at reduced speeds until the rotor temperature is raised to approximately plus 150 F. The rotor is then brought to normal running speed.
